# Manhole Inspection Summary

Manhole # S31UU1008MH

Insp Date: **1/16/07 11:54 AM**

**Location** Address: **5001 SAINT ALBANS WAY**

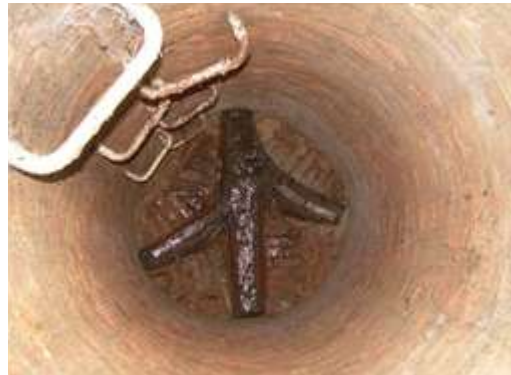
Top View

Count: **6** Missing: **0** ☒ **Corroded**

Corroded steps.

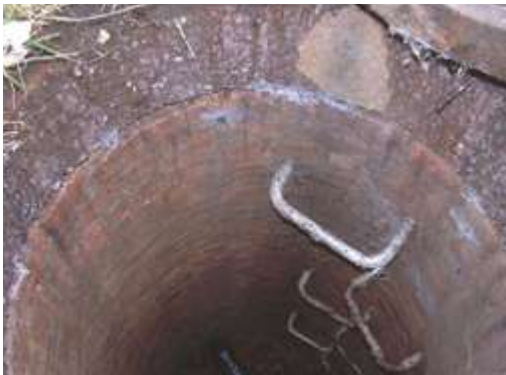
Defect

Condition: ☐ Sound ☐ Cracked ☐ Root Intrusion ☐ Loose Brick ☒ **Deteriorated**

Infiltration: ☐ None ☒ **Joint** ☐ Cracks ☒ **Mortar** ☐ Roots ☐ Wall

Infiltration: ☐ None ☐ Joint ☐ Cracks ☒ **Mortar** ☐ Roots ☒ **Wall**

Adjustment deterioration and infiltration.  
Barrel infiltration - other side.

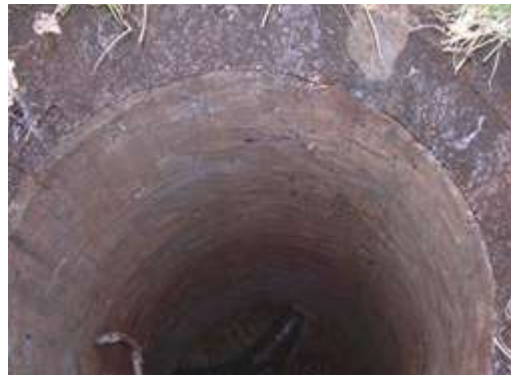
Defect

Adjustment deterioration and infiltration.  
Barrel infiltration.

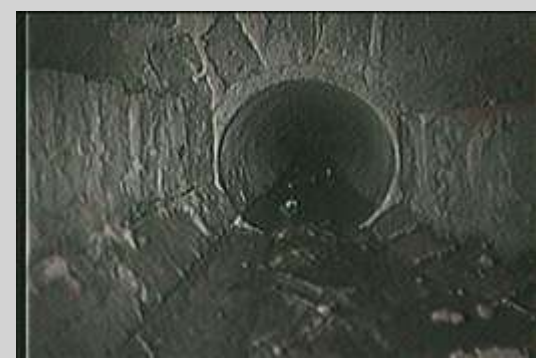
### 8 in. Circular Gravity Sewer Pipe Out @ 12 O'Clock

Infiltration: **None** Pipe Seal Cond: **Cracked**

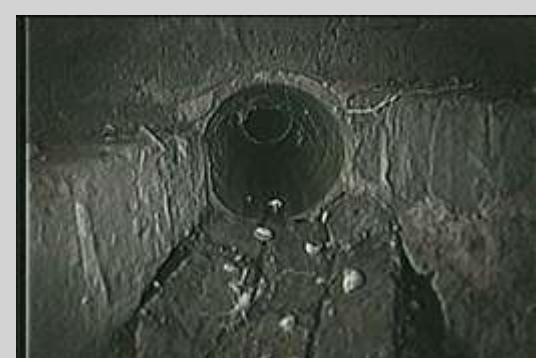
### 6 in. Circular Gravity Sewer Pipe In @ 4 O'Clock

Condition: ☐ Sound ☐ Cracked ☐ Root Intrusion ☒ **Deteriorated** ☐ Leaks ☐ Debris

Channel deterioration.

Infiltration: **None** Pipe Seal Cond: **Roots**

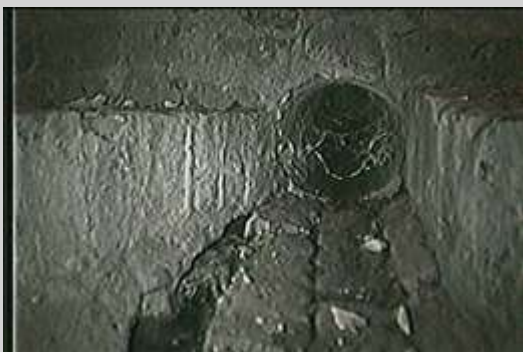
### 6 in. Circular Gravity Sewer

Infiltration: **Evidence** Pipe Seal Cond: **Unknown**
